TECHNICAL INSPECTION REPORT

OPERATION CROSSROADS. U.S.S. SKIPJACK (SS184).
TEST BAKER, VOLUME 2[U].

Bureau of Ships Group technical inspection rept.,

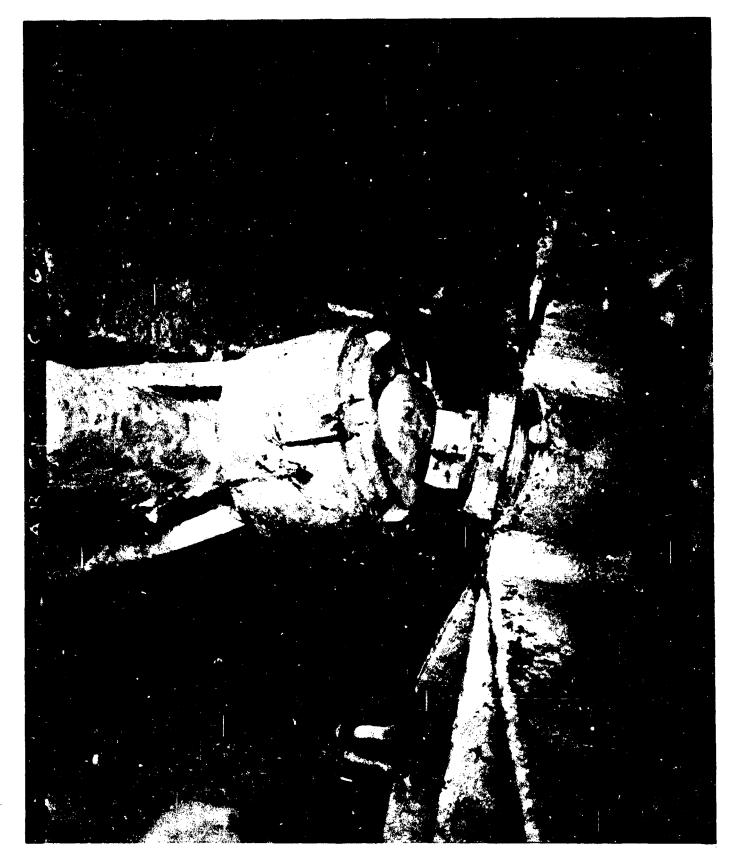
AB-CR-MIG-6522-5. Ball socket joint on flood valve cover in main ball-ast tank 2 G.

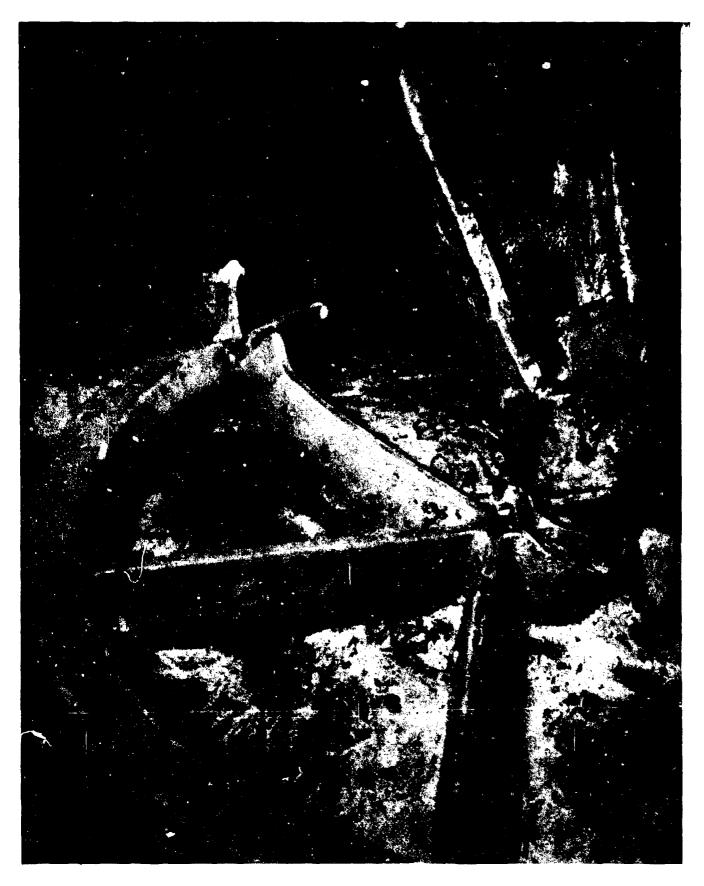
AB-CR-MIG-6522-4. Damage to flood valve cover and links in main ballast tank 2 G.

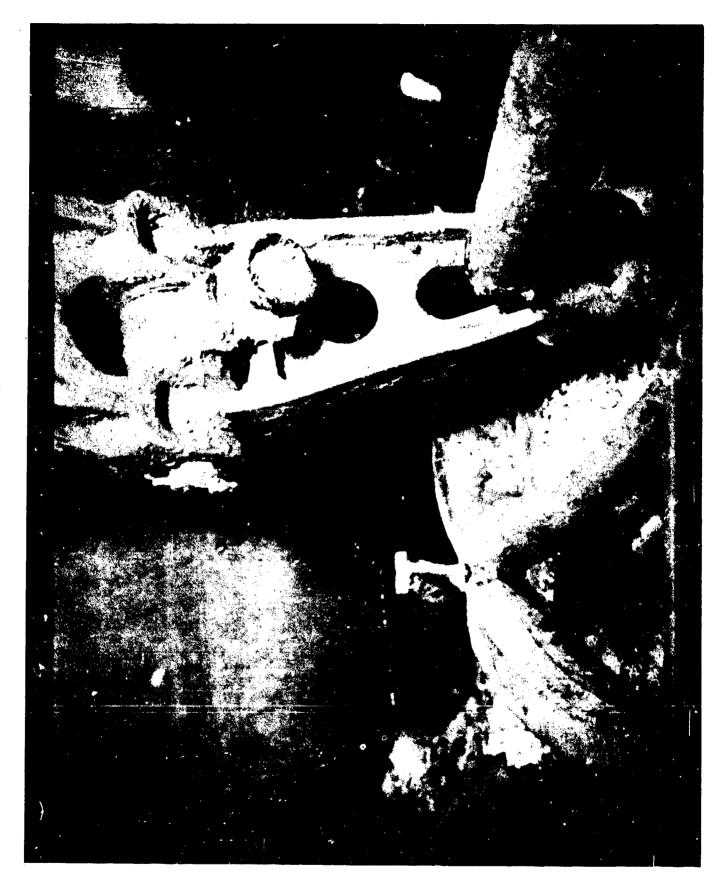
AB-CR-MIG-6522-2. Damage to flood valve cover and links in main bullast tank 2 B.

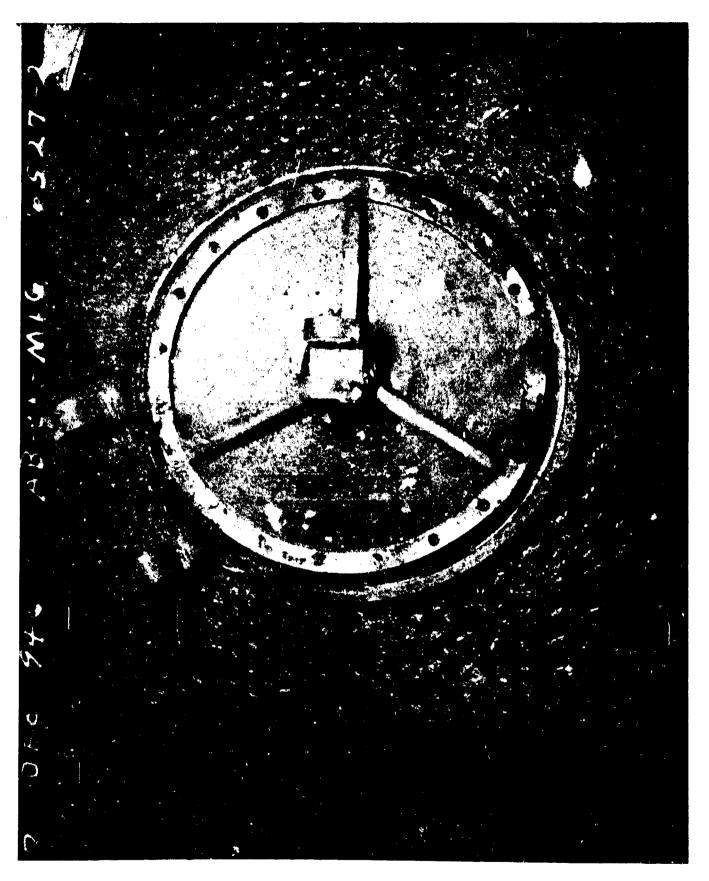
AB-CR-MIG-6527-2. Flood valve cover for negative tank.

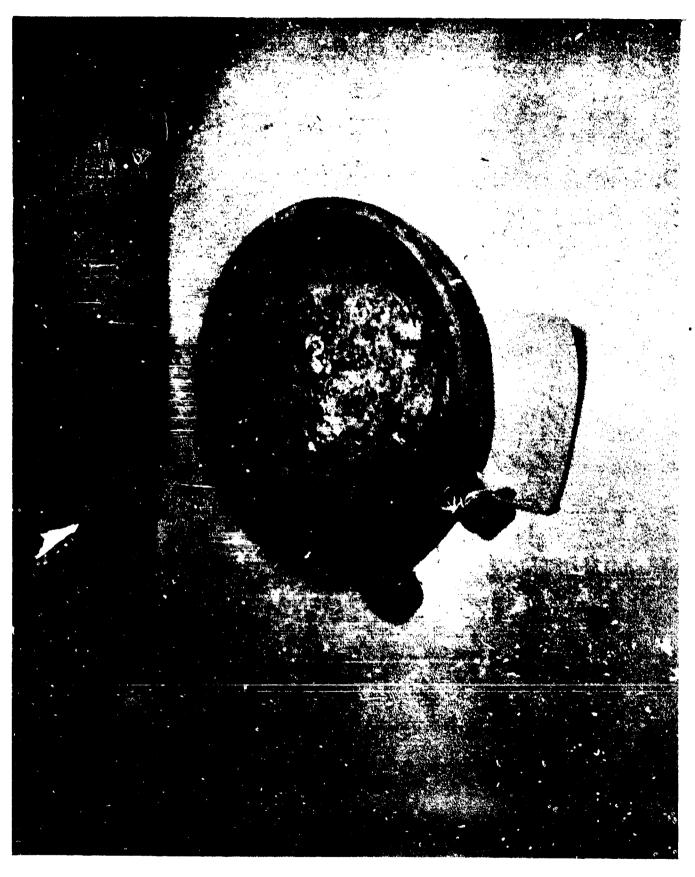
AB-CR-MIG-6519-3. Emergency vent valve clapper for main ballast tank 2 B. Note gasket.

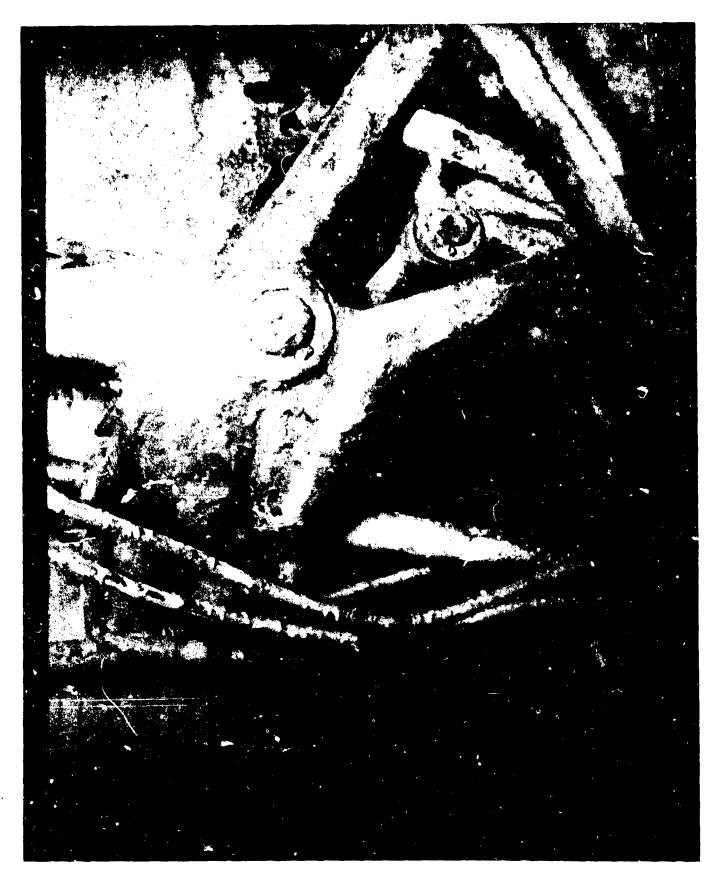
AB-CR-MIG-6522-1. Emergency vent valve linkage for main ballast tank 2 E.

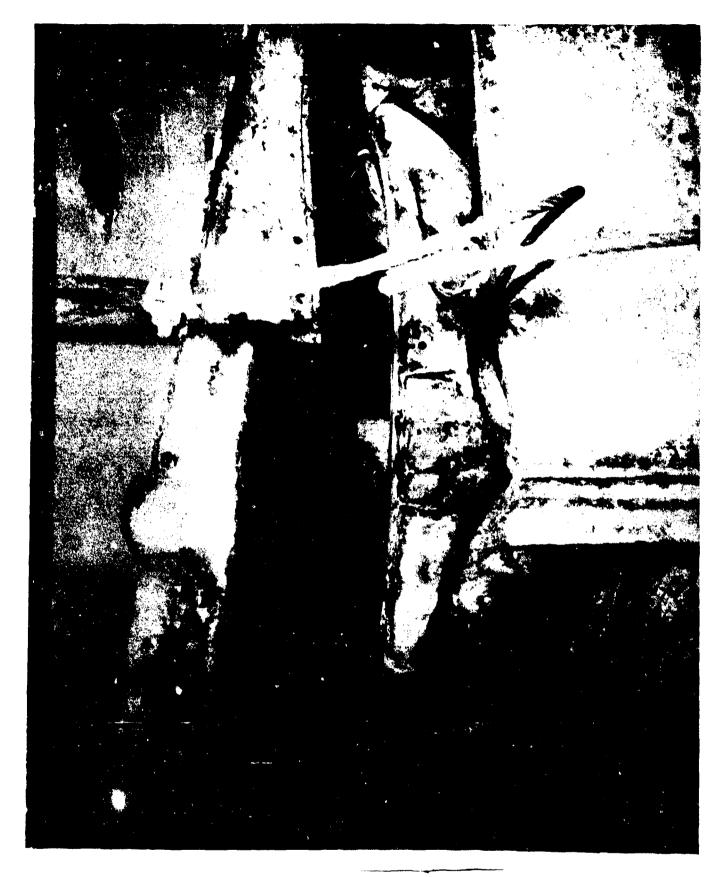
AB-CR-MIG-6518-8. Main engine air induction valve, starboard side.

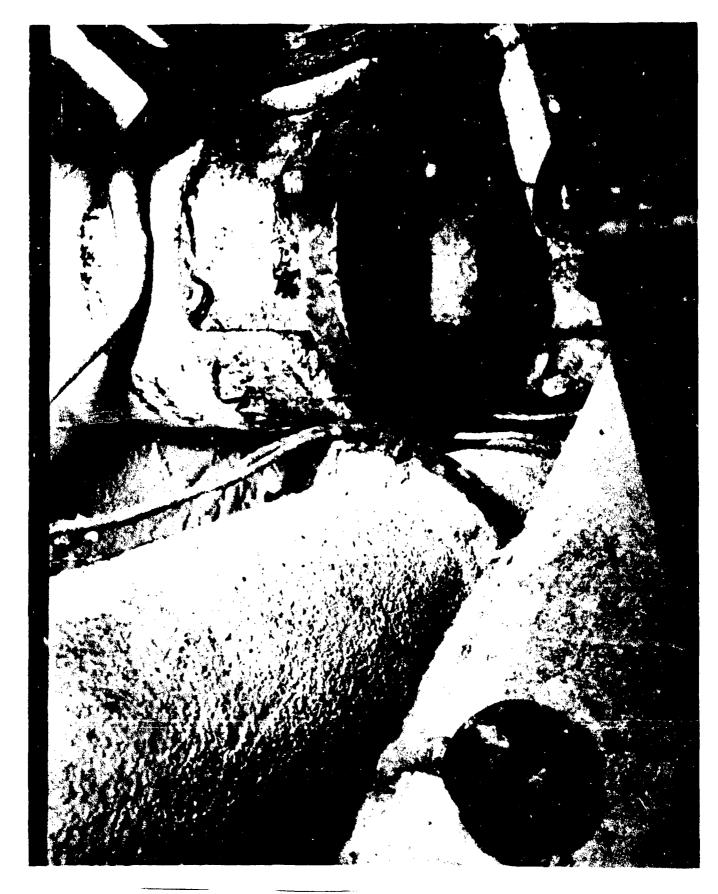
AB-CR-MIG-6519-11. Typical rubber gasket in inboard ventilation line.

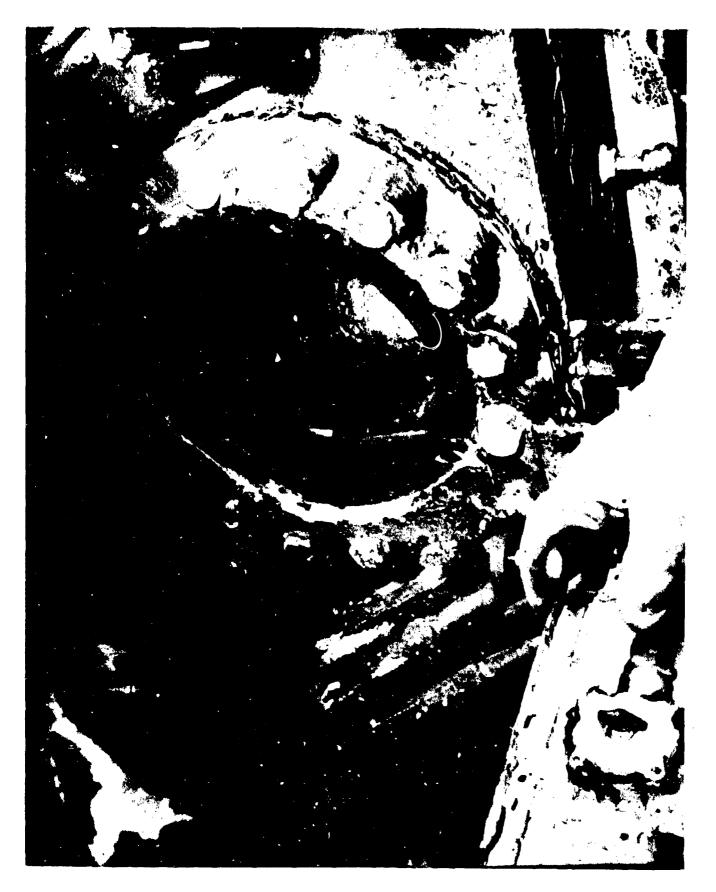
AB-CR-MIG-6528-5. Bulkhead ventilation flapper valve in bulkhead 108, looking aft. Note gasket.

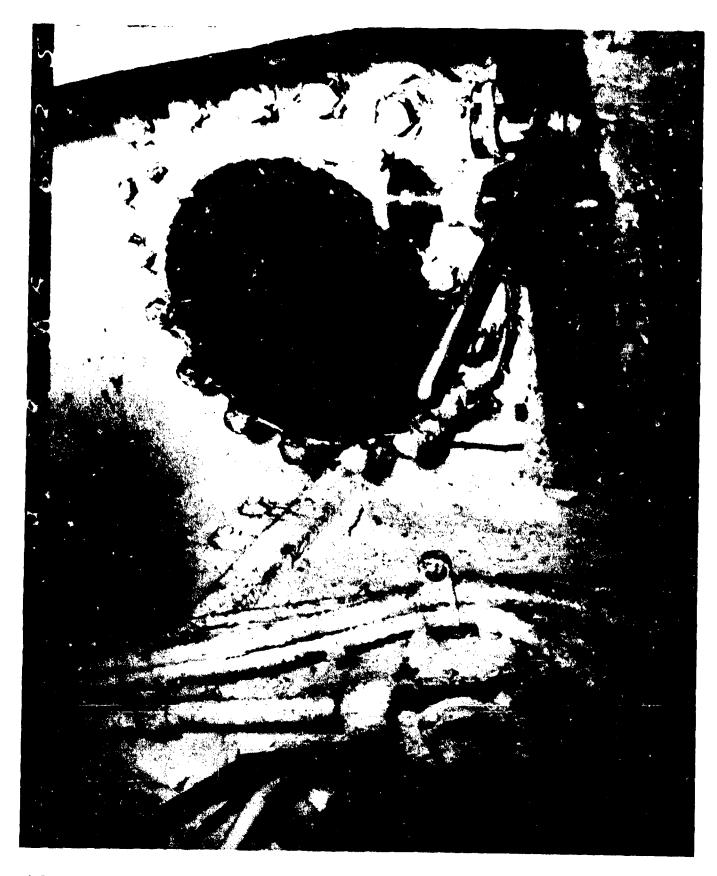
AB-CR-MIG-6512-5. Bulkhead ventilation flapper valve in bulkhead 130, looking aft. Note gasket.

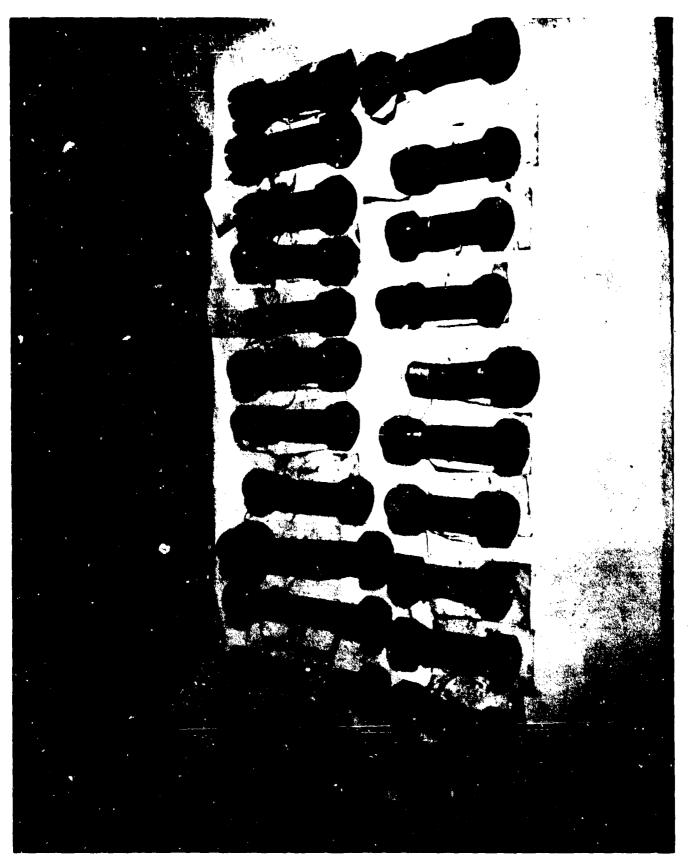
AB-CR-MIG-6513-9. Machinery holding down bolts.

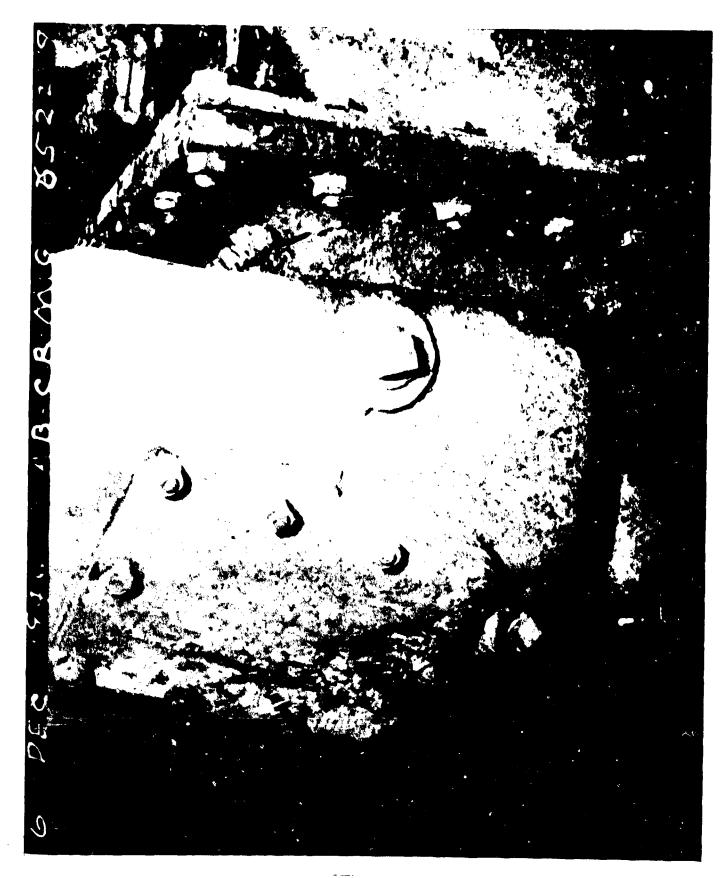
AB-CR-MIG-6522-9. #4 Main engine outboard exhaust valve, showing crack in casting.

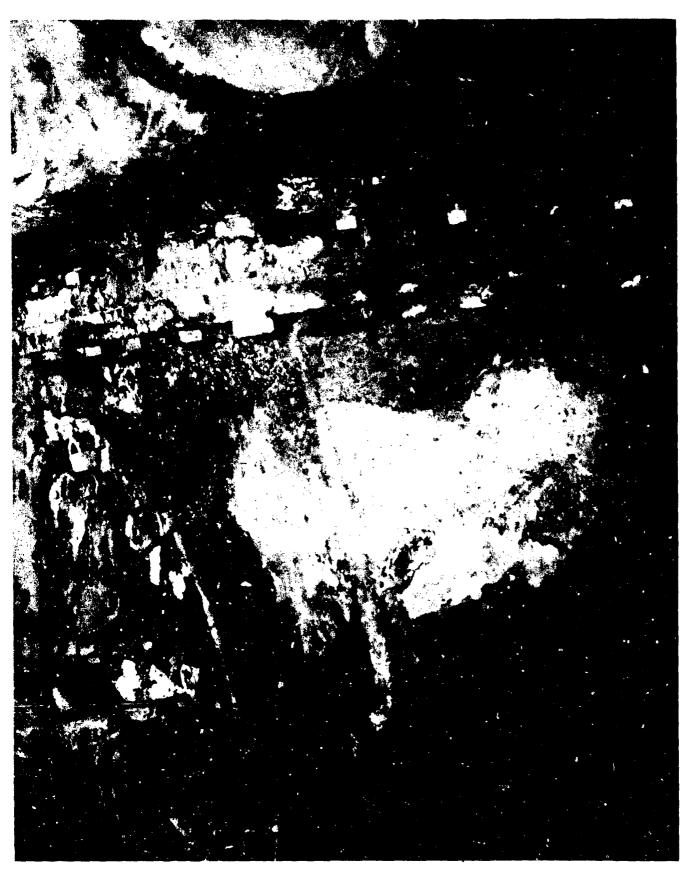
AB-CR-MIG-6522-10. #4 Main engine outboard exhaust valve on side opposite to crack in casting.

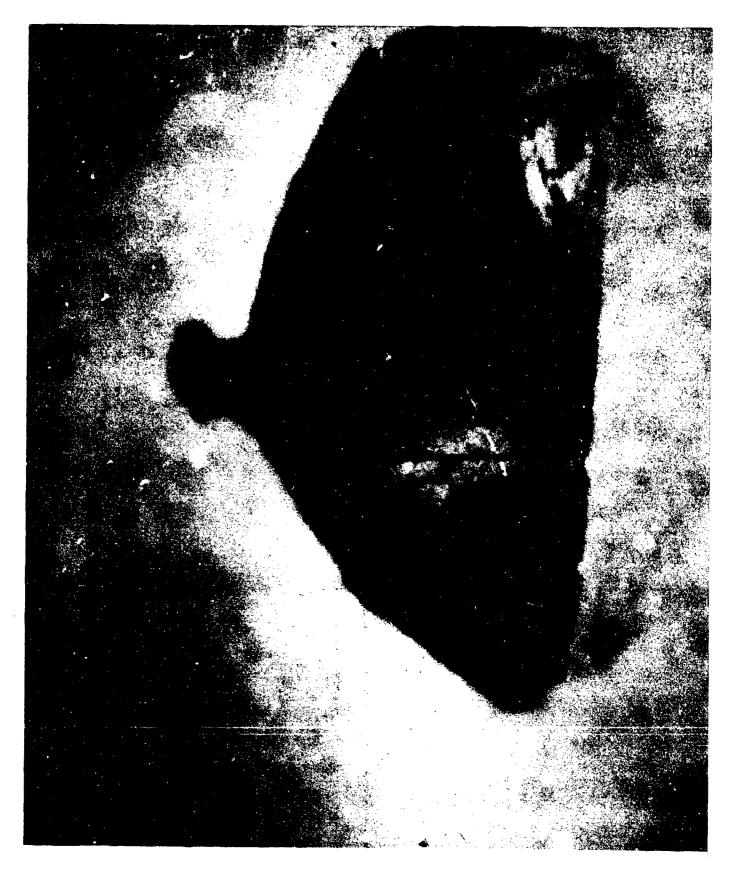
AB-CR-SM-6501-3. #2 Main engine muffler entering exhaust pipe.

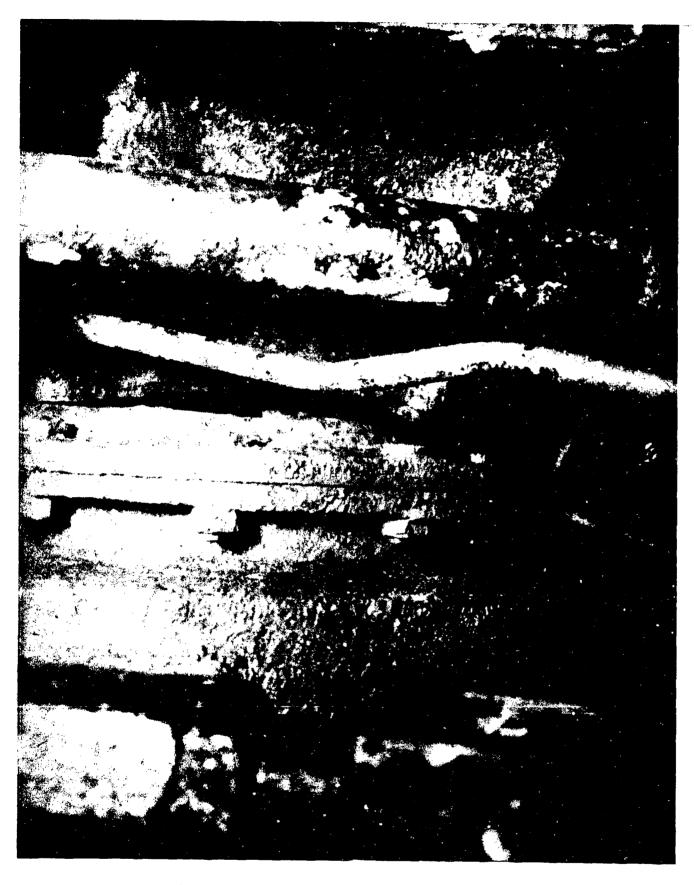
AB-CR-MIG-6522-6. #2 Main engine muffler entering exhaust pipe showing pipe collapsed and pulled away from flange.

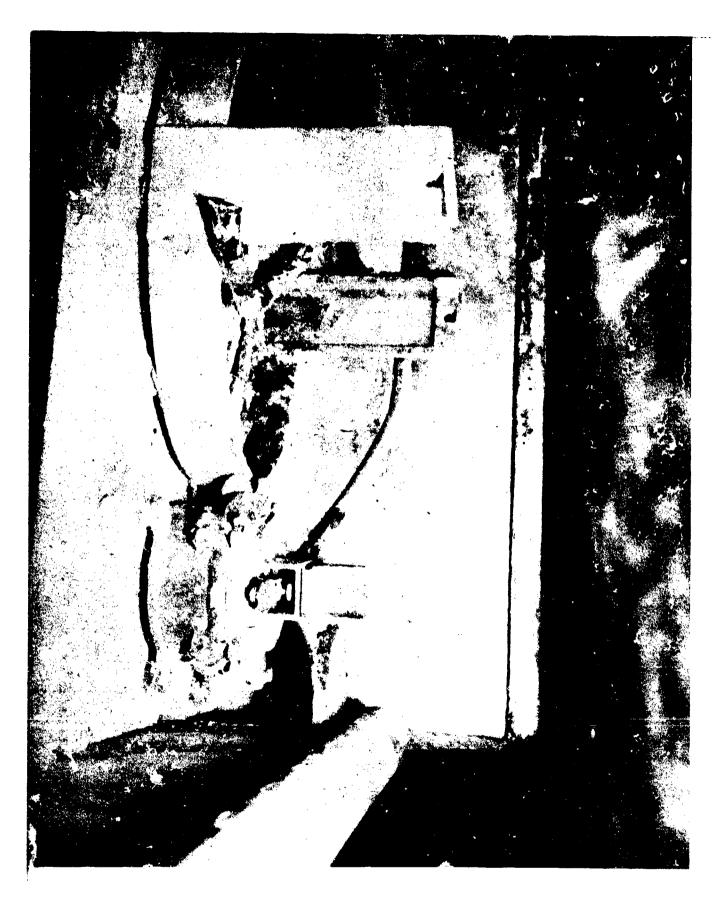
AB-CR-SM-6501-1. Auxiliary engine muffler looking to port showing failure along butt weld.

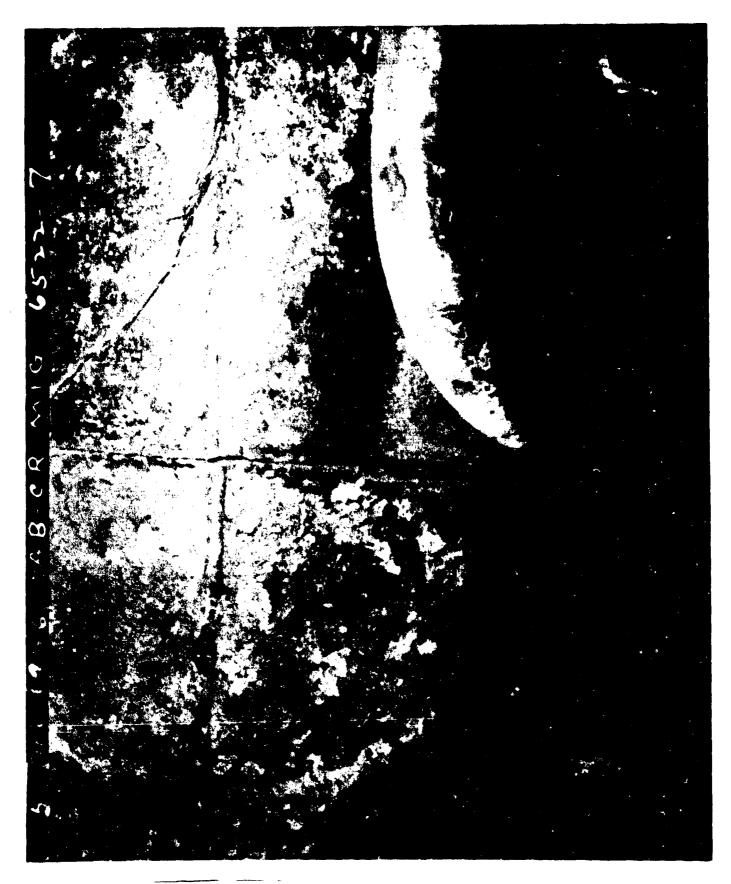
AB-CR-MIG-6522-7. Auxiliary engine muffler showing rupture at center weld.

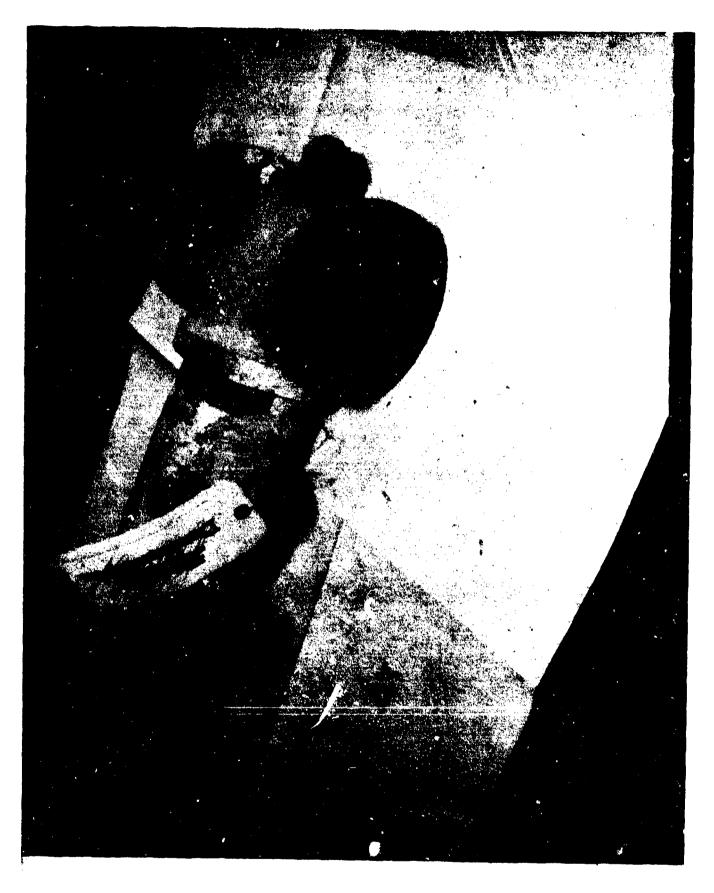
AB-CR-MuG-6517-7. #2 Main engine fresh water line to header. Leaks in silver soldering at reducing tee.

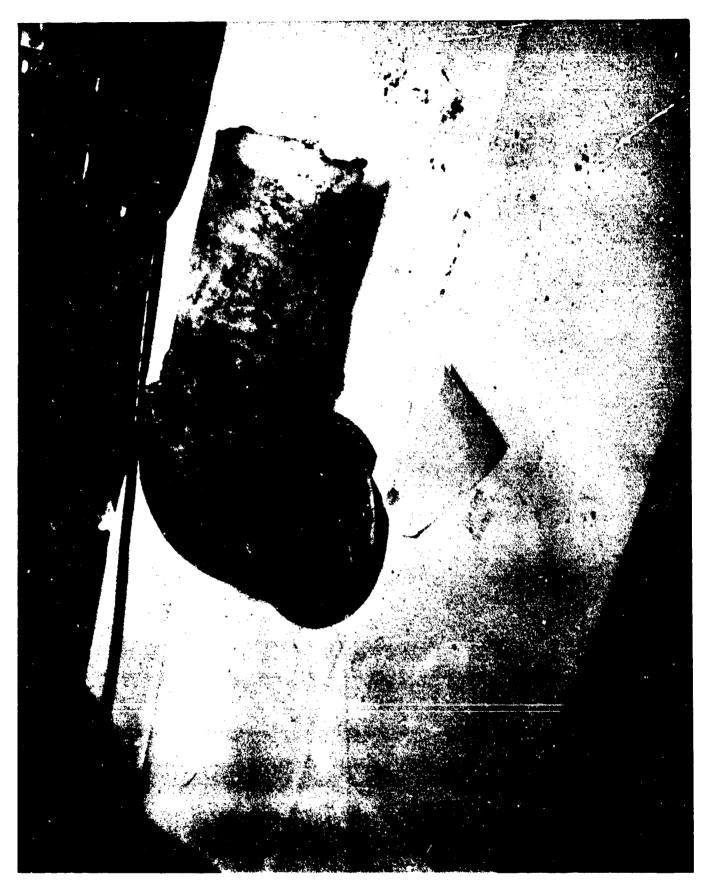
AB-CR-MIG-6517-6. #2 Main engine fresh water to header pipe, outboard of check valve.

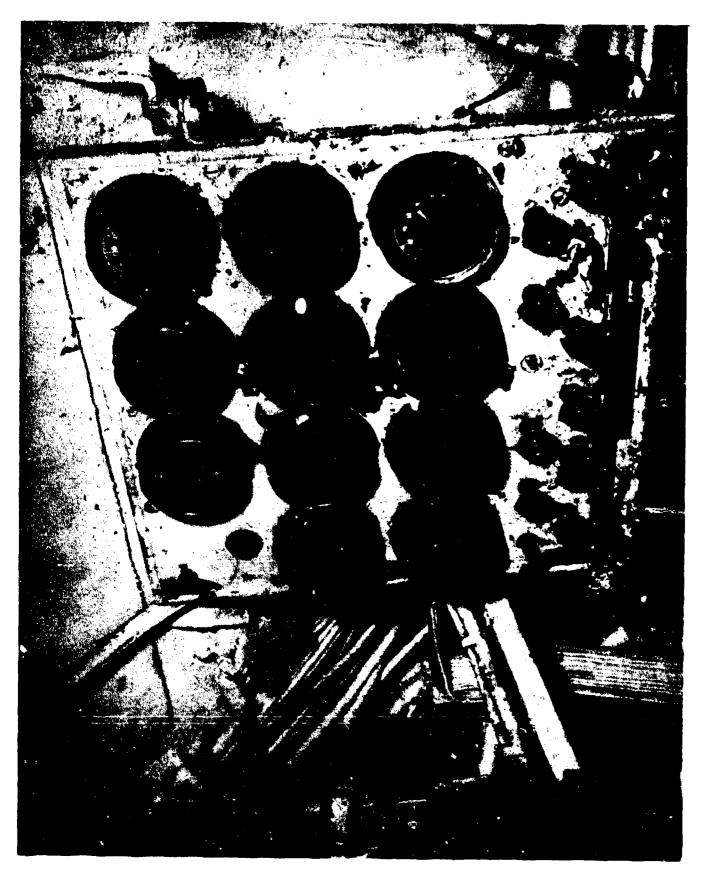
AB-CR-MIG-6518-9. #1 Main engine gauge board, representative of all.

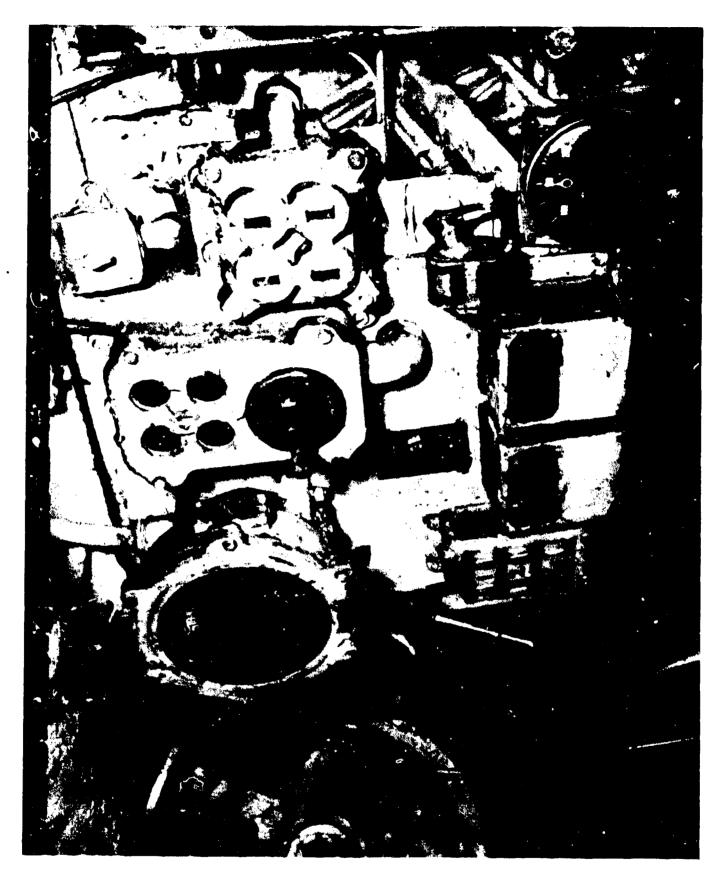
AB-CR-MIG-6518-9. #1 Main engine meter and control board, representative of all.

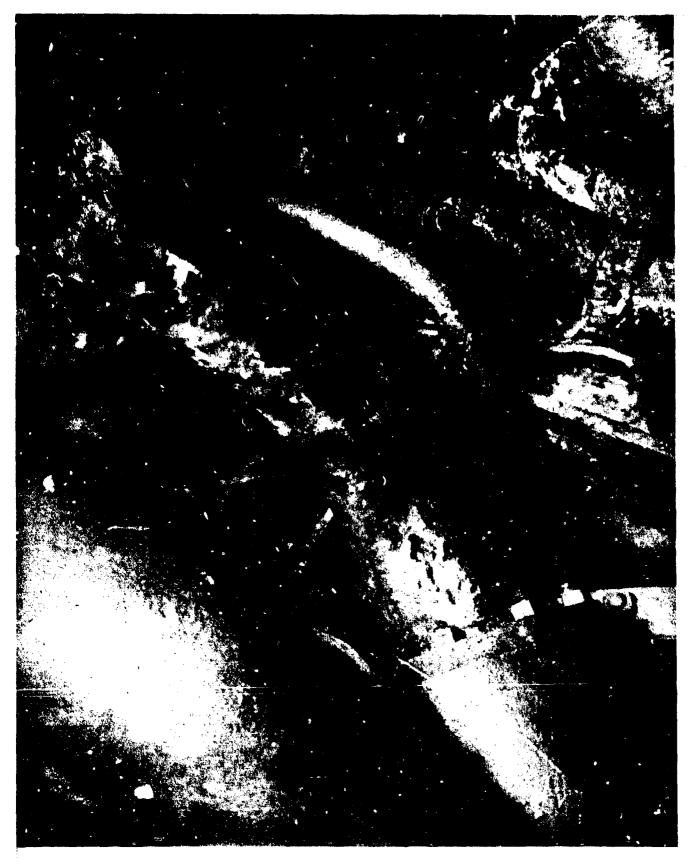
AB-CR-MIG-6516-11. Lubricating oil discharge from #4 Main engine lub oil cooler.

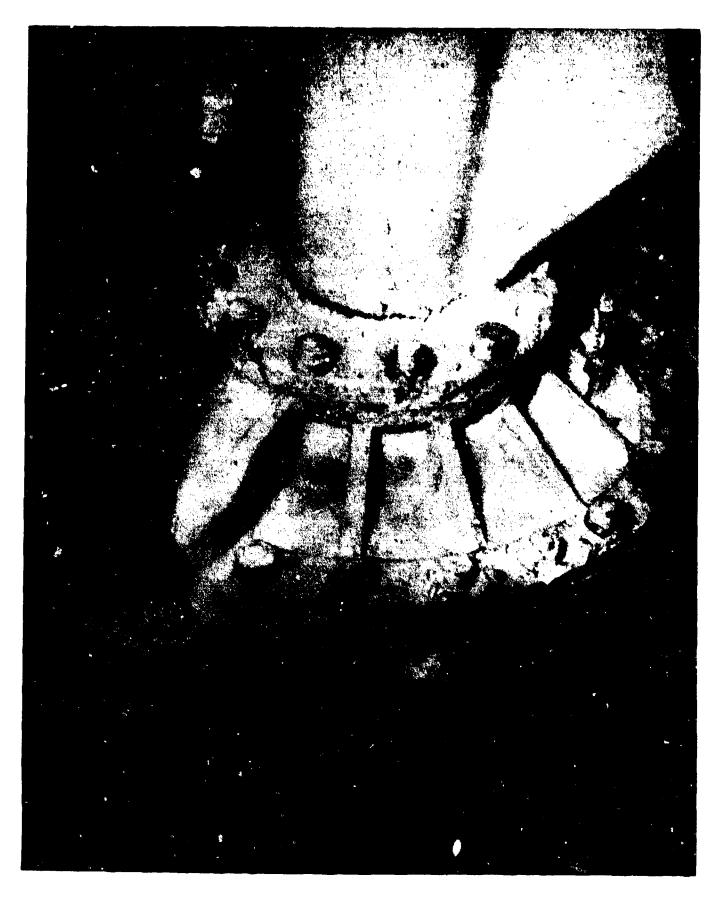
AB-CR-MIG-6507. Bow plane rigging gear worm gear case in forward torpedo room overhead showing crack in case.

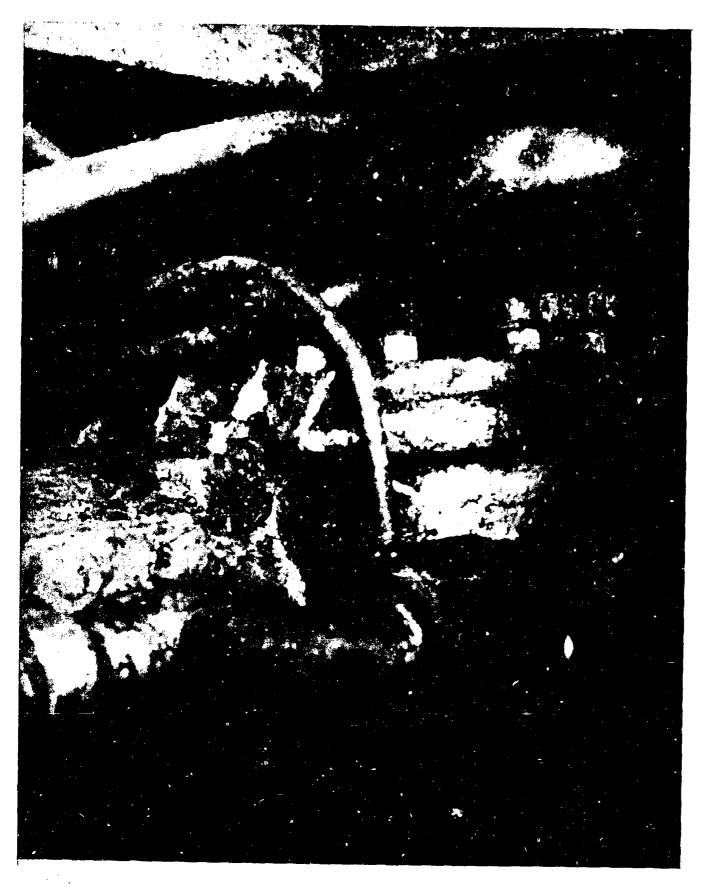
AB-CR-MIG-0522-11. #1 H.P. air compressor showing crack in upper motor support.

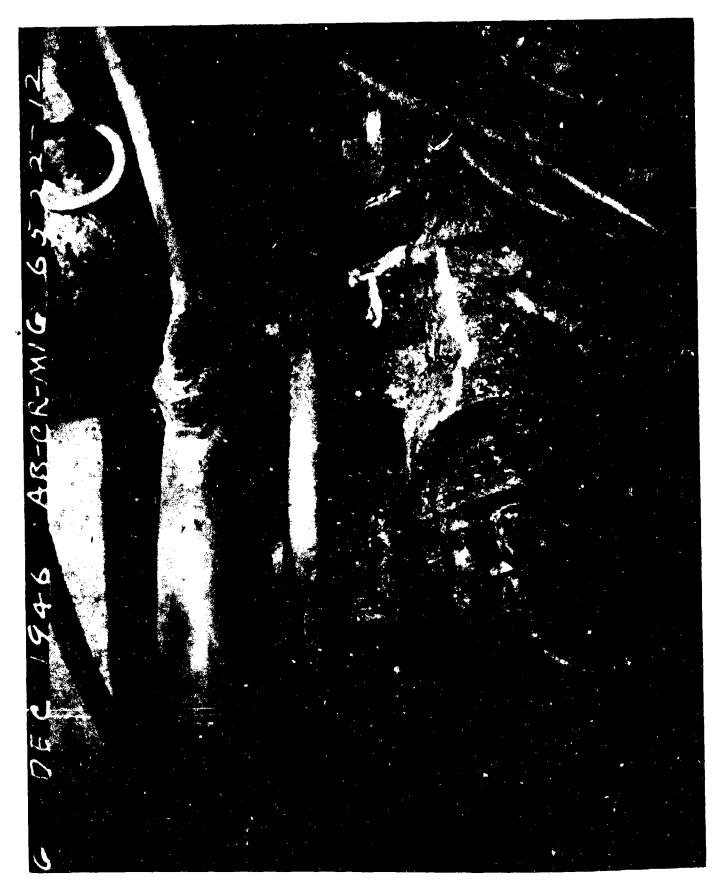
AB-CR-MIG-6522-12. #2 H.P. air compressor snowing crack in upper motor support.

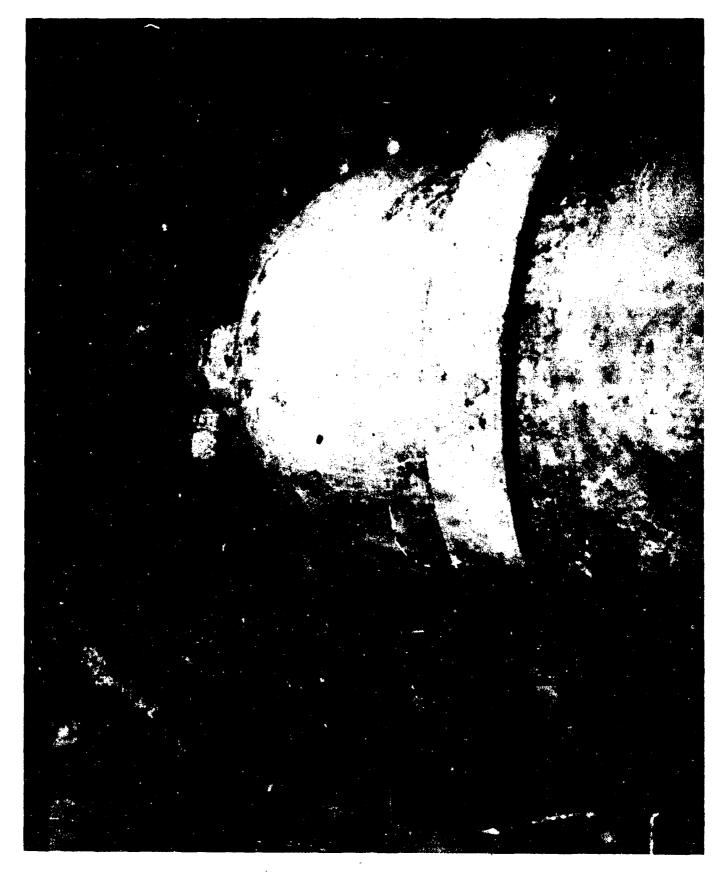
AB-CR-MIG-6519-7. Accumulator air flask in pump room showing pipe adaptor broken off flask head.

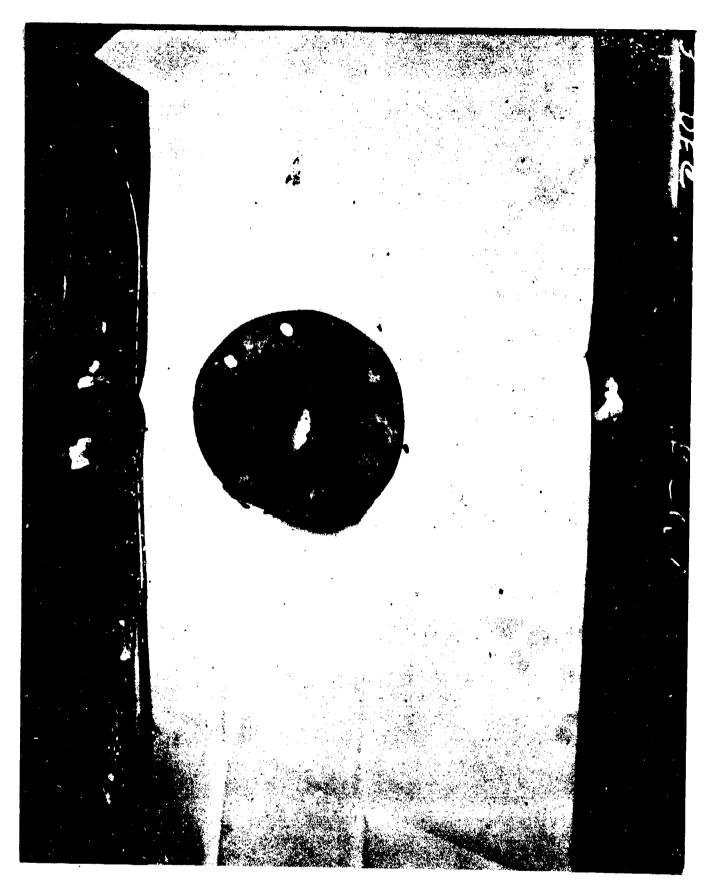
AB-CR-MIG-6517-3. Section of fuel oil filling and transfer line at after bulkhead in crew's galley.

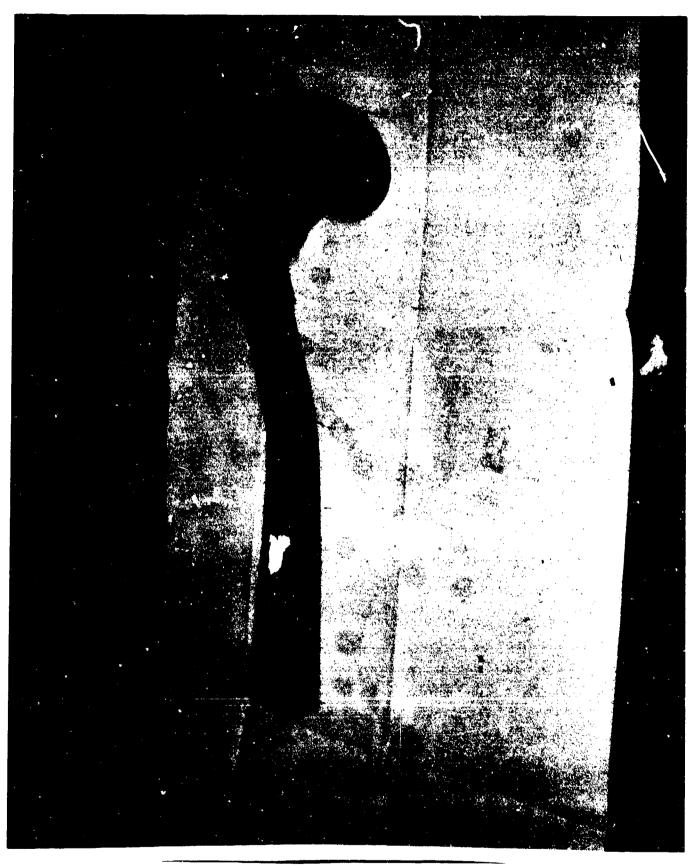
AB-CR-MIG-6517-2. Circulating water pipe for #4 main motor, port side of motor to reduction gear lub oil cooler.

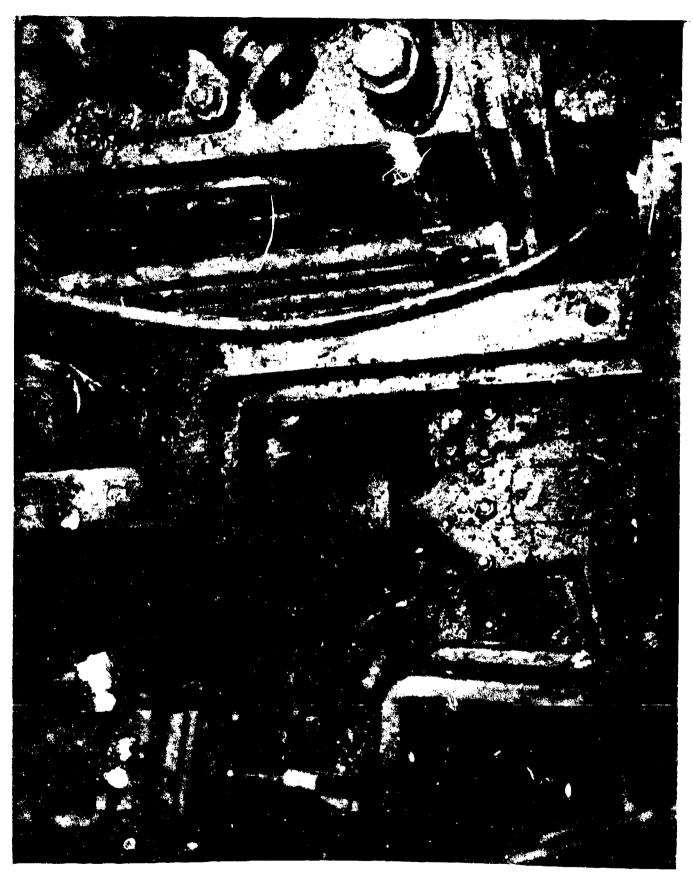
AB-CR-MIG-6516-9. Salt water circulating water discharge from #4 main motor cooler.

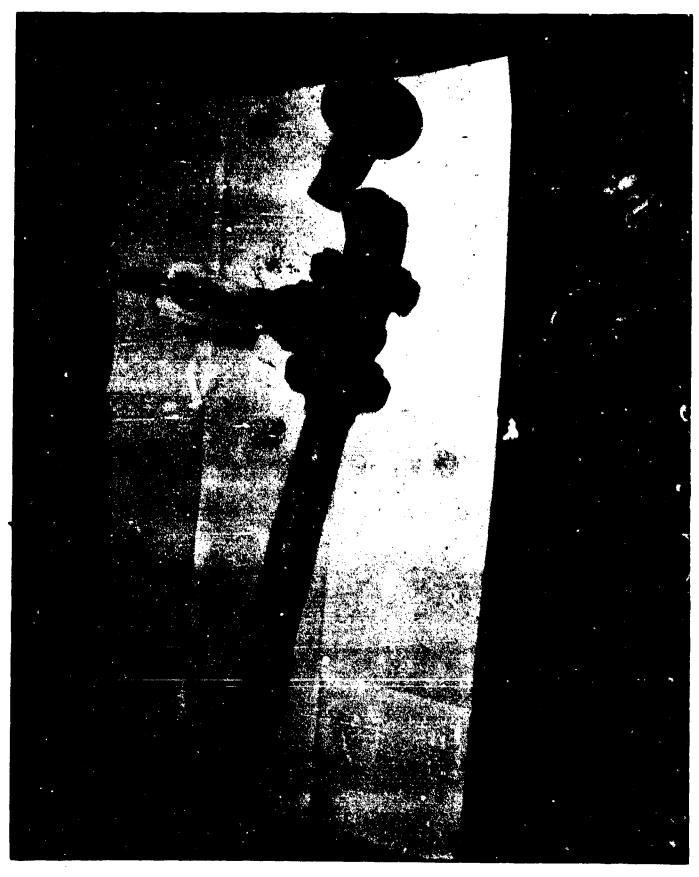
AB-CR-MIG-6517-4. #3 Main motor circulating water pipe from starboard side of motor cooler to reduction gear lubricating oil cooler.

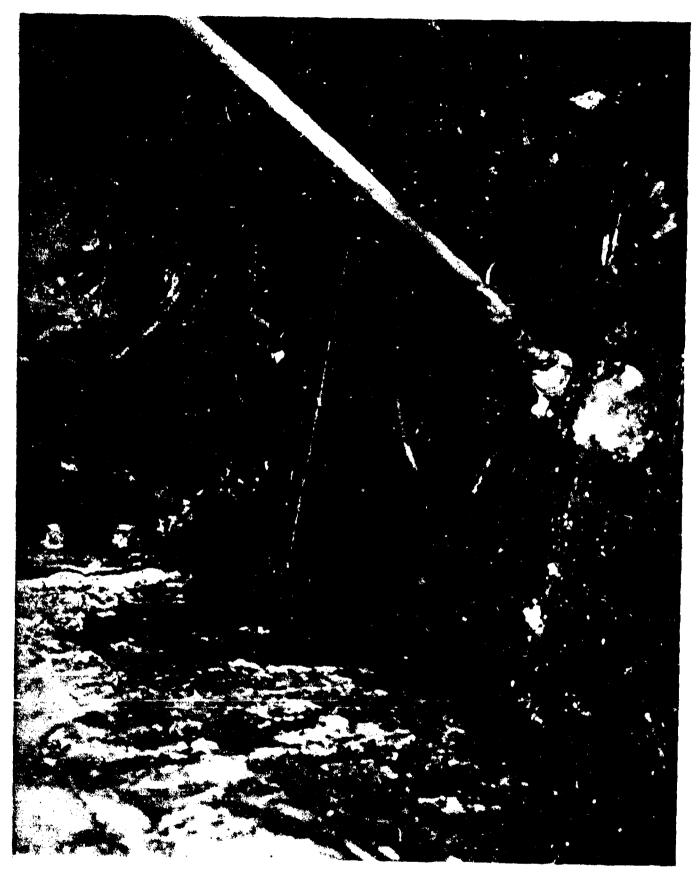
AB-CR-MIG-6512-7. No. 2 main motor sea suction valve - 100 showing leak under flange.

AB-CR-MIG-6512-6. #2 Main motor sea suction valve.

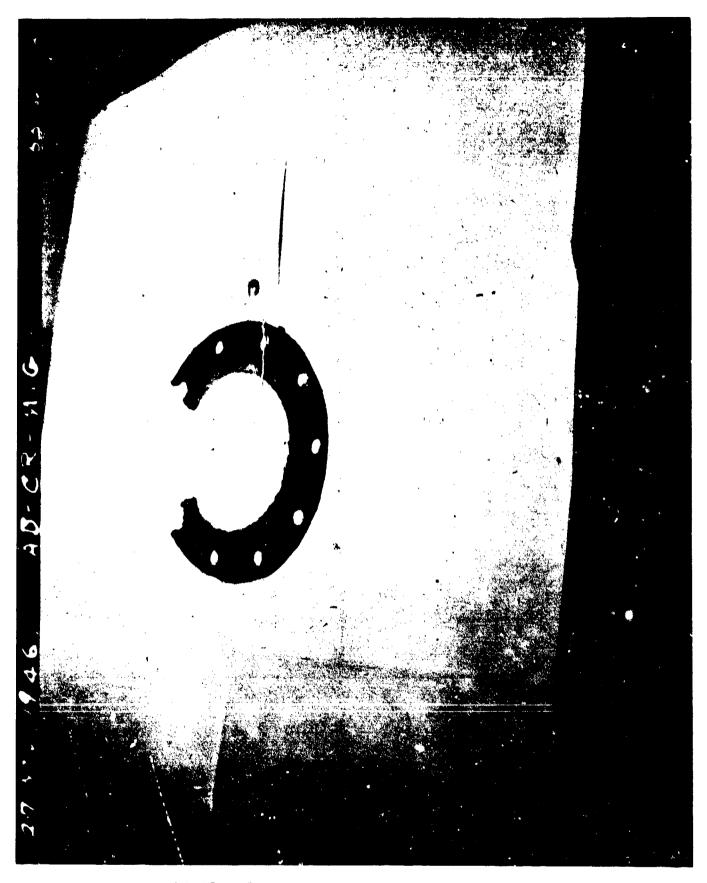
AB-CR-MIG-6514-12. #2 Main motor sea suction valve gasket for hull flange.

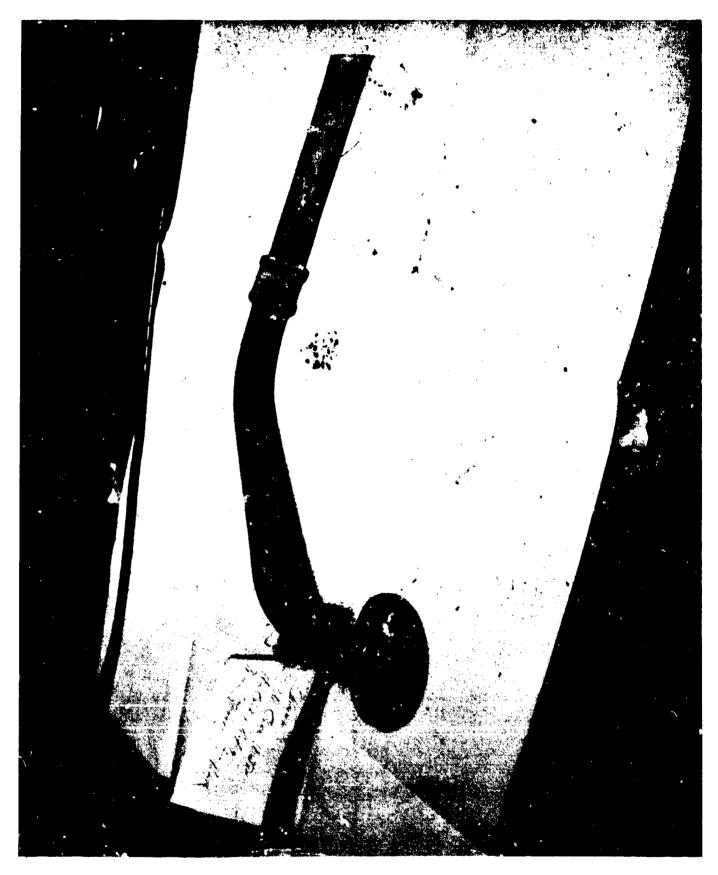
AB-CR-MIG-6517-5. Sea water circulating water for air conditioning and refrigeration from strainer to pump.

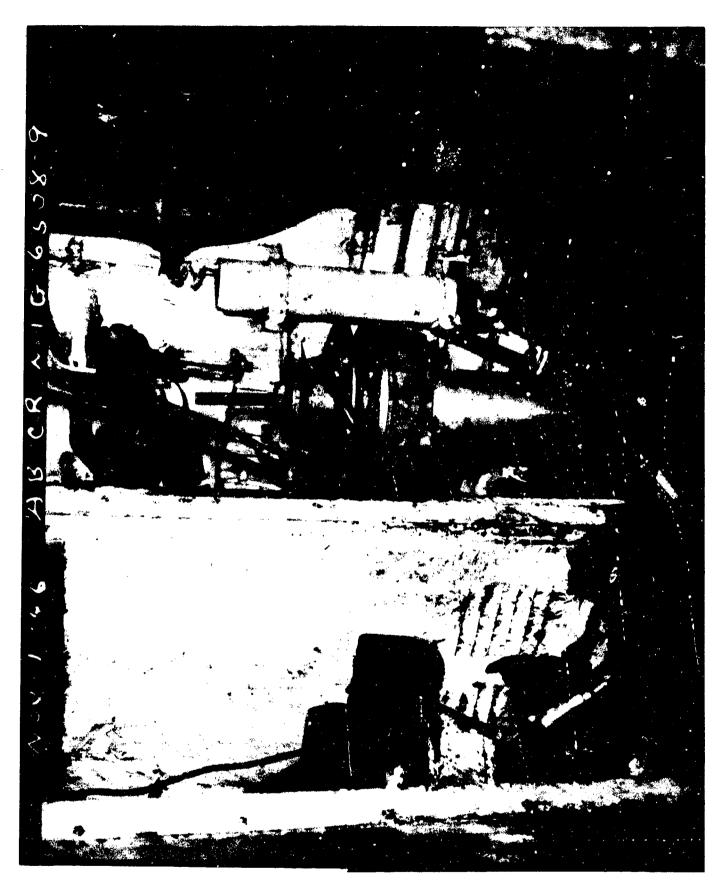
AB-CR-MIG-6508-9. Starboard sound head shaft broken and slipped down.

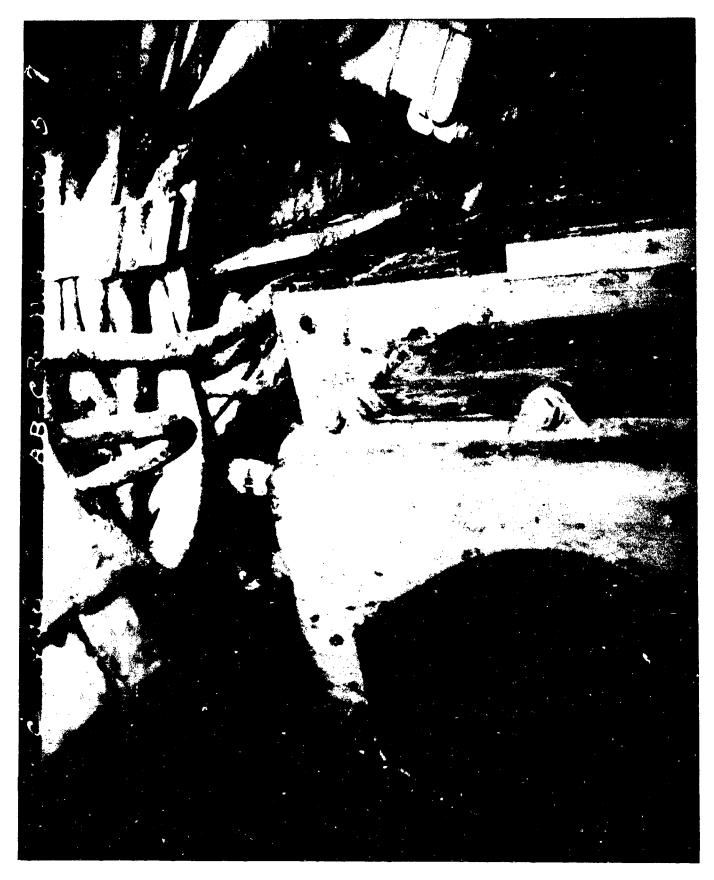
AB-CR-MIG-6513-7. Control cubicle starboard side front top foundation bolt.
